# Republic of the Marshall Islands

### MARINE SAFETY ADVISORY NO. 23-19

**Subject: STRUCTURAL FAILURE OF PROVISION CRANE MAINTENANCE PLATFORM**

**Date: 30 July 2019**

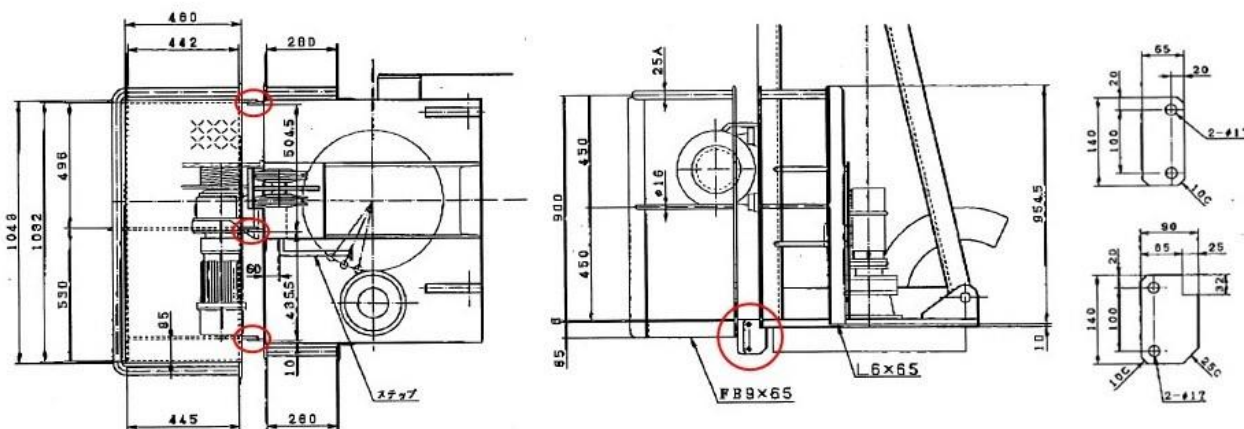
The lower maintenance platform consisted of two parts: the main platform (welded to the pedestal), and the platform extension. As built, the extension was attached to the main platform by three bolted connections (see Figure 1). Each of these connections had a bracket welded to the main platform and another to the platform extension. The brackets were notched where they were welded to the main platform. Each bracket set had two bolts installed through the holes connecting the extension and the main platform sections. There was no physical connection at the railing. There were no modifications to the maintenance platform since the ship was built and delivered from the shipyard in 2006.

Figure 1: Drawing of the lower maintenance platform. The brackets are circled in red. Note the absence of a physical connection at the railing. On the right are detailed drawings of the brackets. On the top is the bracket that is welded to the platform extension and on the bottom is the bracket that is welded to the main platform.

When examined as part of the Administrator's marine safety investigation, it was determined that the welds for all three of the brackets that were attached to the main platform had failed. Heavy corrosion was observed on the main platform where all three brackets attached. The ship's crew reported that the corrosion was not visible prior to the extension falling. It also appeared that the welds lacked full penetration.

1. Inspect the maintenance platforms for cranes fitted on-board the ships in their managed fleet to determine if they include any portion that is supported by brackets such as those shown in Figure 1. If they do, ship managers should ensure that:

- the connections are inspected to determine if they show any indication of damage or deterioration (ship's staff should be aware that damaged welds or rust might be obscured by paint);

- any potential damage or deterioration is reported and corrected as soon as possible;
  - if only brackets such as those shown in Figure 1 are used to connect any part of the maintenance platform to the crane, to consult with the crane manufacturer regarding recommendations for reinforcing the connection and to make the required modifications as soon as possible;

- ship's staff do not use the platform until any required modifications or repairs are completed; and
  - the maintenance and inspection procedures for shipboard cranes are reviewed and, if necessary, revised to ensure that the connections are subject to regular inspections.
