# UNITED STATES COAST GUARD

## MARINE SAFETY LESSONS LEARNED

Lessons Learned 01-19

### **Avoid delays and keep your ship on schedule!** **Does your BilgMon 488 Bilge Alarm / Oil Content Meter operate properly?**

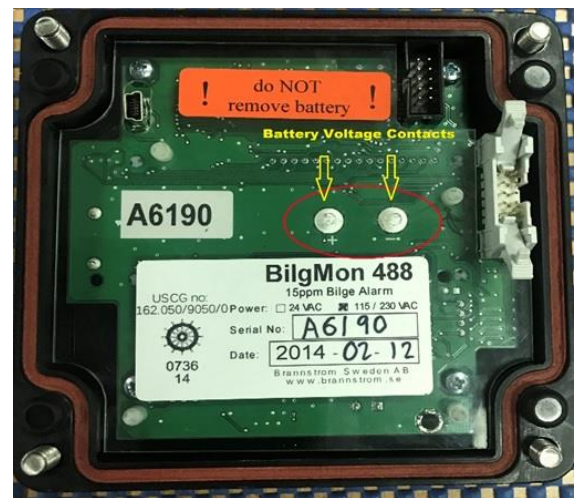
The specific monitor in these cases was the BilgMon 488 model manufactured by Brannstrom, a Swedish company. The older model, BilgMon 488 shown on the right, has a battery that is not replaceable by the crew inserted behind the circuit board of the Bilge Alarm. The purpose of the battery is to maintain the stored data and Real Time Clock (RTC) when the unit is disconnected from a power supply. The circuit board contains two contact points which provide the ability to measure the battery voltage. In all four cases, the battery voltage was extremely low and failed to provide the required 2.5 volts necessary to maintain the stored data without error. As a result, when the data was viewed on the LCD screen it was scrambled and inaccurate. The operator's manual for this model clearly states that, under no circumstances should the battery be removed. Furthermore, a red warning sticker is affixed to the circuit board as pictured above. Attempting to remove the battery in this circumstance may cause an unrecoverable error, failure and data loss. A manufacturer's representative indicated that the battery was originally designed to last the lifetime of the device and that if the RTC stops due to a power supply

failure combined with a low back-up battery voltage, the unit is locked down and the display reads "RTC check: FAILED." [Click here for the applicable manual.](#)<sup>1</sup>

As a result of these discoveries the Coast Guard **strongly recommends** that ship owners and operators whose vessels use the BilgMon 488 to:

- Remind vessel engineers to routinely review the stored data available through the LCD display ensuring that the data matches the information recorded in the ORB and actual OWS operations.
- Maintain awareness that Port State Control Officers performing MARPOL examinations will verify that the BilgMon 488 is recording data properly and is aligned with the ORB entries. **Avoid potential departure delays.**

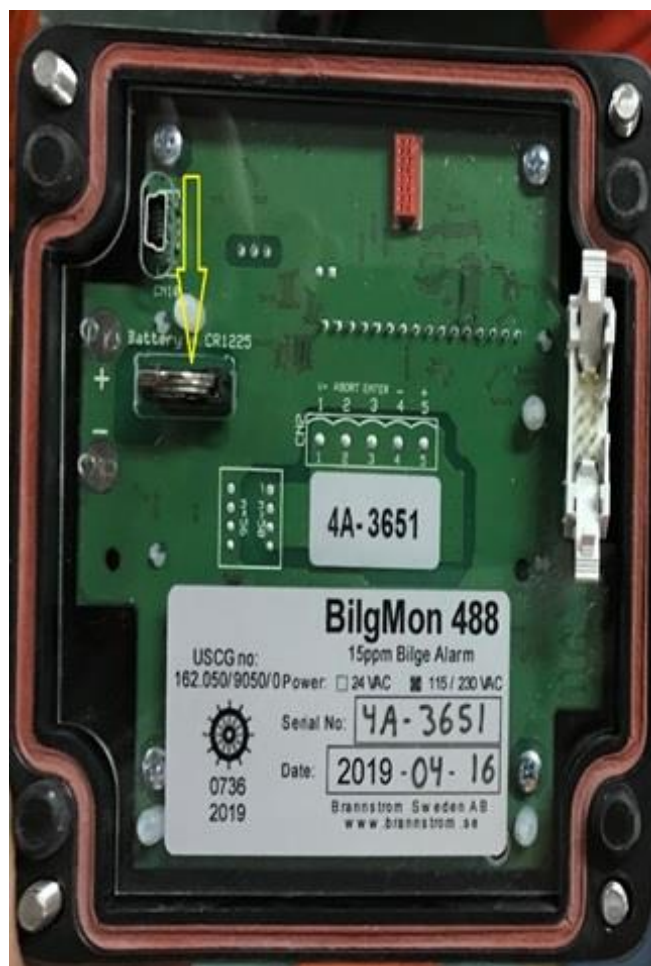
The newer model BilgMon 488 is equipped with a replaceable battery shown on the right below the yellow arrow. As a result, when the battery weakens the unit display will read "Batterylow: 0.5V Replace battery." The battery can then be safely removed because it utilizes a capacitor that ensures enough energy to maintain the stored data for several hours. [Click here for the applicable manual.](#)<sup>2</sup>
