## **MARINE SAFETY ADVISORY No. 12-18**

Subject: QUALITY ISSUE IN COSMO MED AND TYPE-APPROVED FIRE DOORS

- FAULTY A-60, A-0, AND B-0 FIRE DOORS

**Date:** 20 April 2018

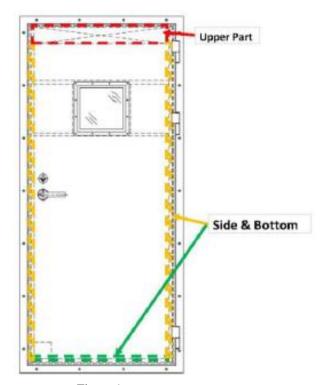
Figure 1

A quality issue has been discovered in fire doors manufactured by COSMO Co., Ltd, where insulation has been found to be partly missing from the upper part, sides, and bottom of the doors (See Figure 1). Fire doors manufactured by COSMO and matching the following criteria may be affected:

However, the affected A-60 rated doors require an on-board repair in order to assure that these A-60 doors meet the requirements of the IMO 2010 FTP Code. The Republic of the Marshall Islands (RMI) Maritime Administrator (the "Administrator") highly recommends that owners and operators with the aforementioned doors check them to determine whether they are affected by the quality issue. COSMO has devised a test which does not require the removal of the doors:

• An approved type of non-combustible material must be injected into the top part of the door through the hole in order to fill the empty space left by the missing insulation.

- The repair work should be carried out by an experienced general outfitter, or by someone who is familiar with drilling and hole cutting. The work must be in accordance with COSMO repair procedure CD-RP-01, Rev. 8.
