For the 2nd half of 2018

PSC Trend

Nov. 20, 2018 K.H. Hwang / Survey Team

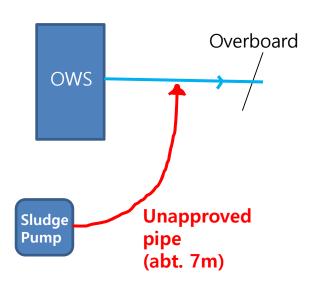
(Oily Water Separator) Unapproved pipe line

Unapproved pipe line from sludge pump was connected to overboard line of O.W.S.

[ship transferred from other class]

It was removed from the overboard line.

Pipe line shall be carefully checked during class survey by KR and patrol by Engineers on board.

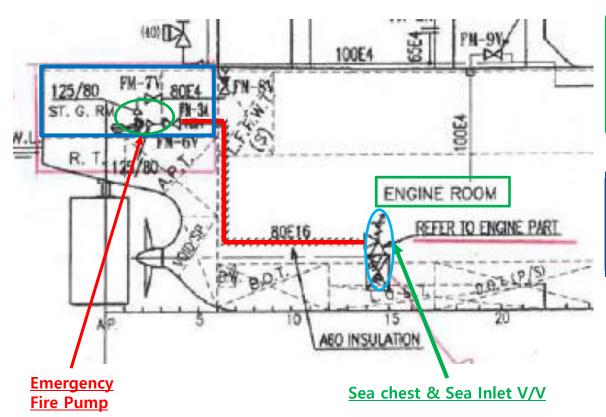
(Emergency Fire Pump) No Control means for sea inlet valve

The emergency fire pump, its seawater inlet, and suction and delivery pipes and isolating valves shall be located outside the machinery space. If this arrangement cannot be made, the sea-chest may be fitted in the machinery space if the valve is remotely controlled from a position in the same compartment as the emergency pump

No remote control means was provided in S.G.Room. (It was fitted in F.C.Station, not in S.G.Room.)

[ship transferred from other class]

It plans to be fitted in the same compartment(S.G.Room) with the emergency fire pump.

It shall be carefully checked during class survey by KR and patrol by Engineers on board.

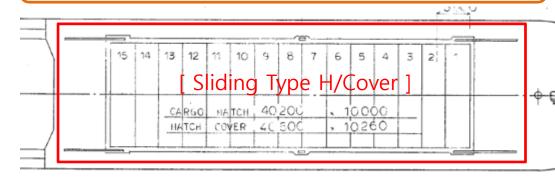
(Cargo Hatch Cover) Tightness

[Holed and Corroded]

After closing h/cover, PSCO found h/cover was not weather tight due to corrosion and holes.

After the temporary repair, the ship went to the next port for the permanent repair.

After closing it, check whether light is transmitted or any corrosion is found.

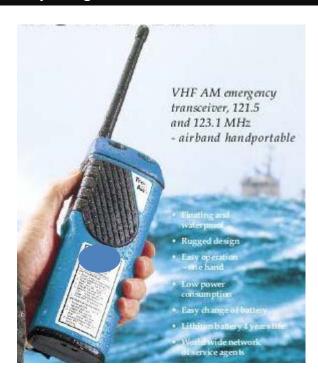
[Sample_Portable Type]

Two-way on-scene radio communication means was not provided on board.

Newly provided due to it's loss

For passenger ship, check whether it is provided on board.
