## **MARINE SAFETY ALERT**

Safety Alert 17-16

#### **MAN B&W Cooling Jacket Failures** ***Using the correct bolts is essential!***

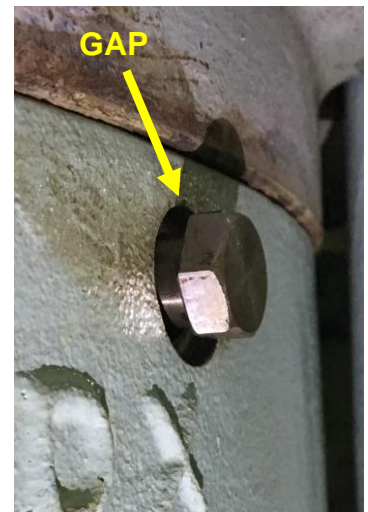
By design, the shoulders of these bolts are longer than the cooling jacket wall thickness. New replacement bolts will often have even longer shoulders. When the bolts are properly tightened there will likely be a gap between the bottom of the bolt head and the outside of the jacket cover. (Image A) The extra shoulder length allows the cooling jacket to position itself concentrically on the bottom of the cylinder cover and facilitate any movement or slight expansion of the o-rings. It also allows for some expansion of the cast iron cooling jacket. If the cooling jacket is slightly positioned non-concentrically on the cylinder cover, some of the bolt head's bottom surface areas may appear as if the bolt is fully tightened against the outside of the jacket cover.

*Image A: Properly secured cooling jacket bolt.*

- Owners, managers and operators ensure that their vessel engineering staffs have access to all available manufacturer service letters for propulsion, electrical generation, steering and other critical equipment; and
- Senior engineering personnel on vessels with MAN B&W MC-C and other similarly constructed engines using the same cooling jacket cover securing method *review* the applicable maintenance procedures and ensure that persons assembling these components know that the shoulder bolts may not butt up against the cooling jacket cover, as breakage may occur if forced, and that regular bolts with no shoulders should never be used.

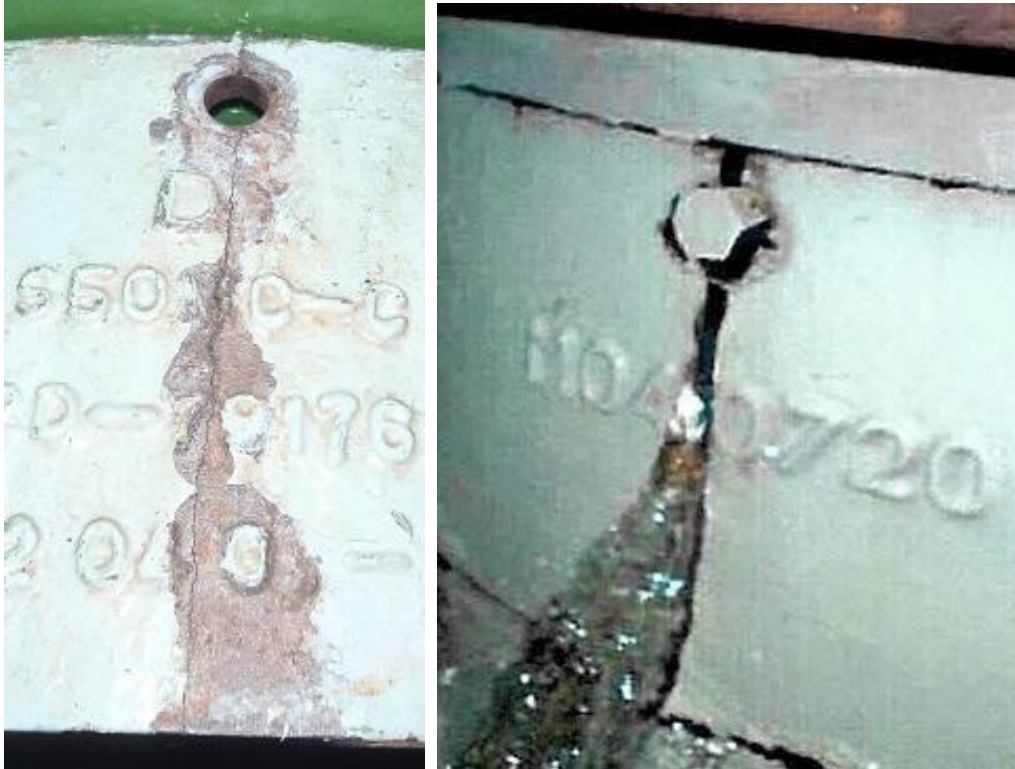
Photographic examples of fractures:

In the past, cooling jackets have fractured vertically through the bolt holes that secure the jackets to the cylinder cover. (Photographs - next page.) These fractures have caused a loss and reduction in cooling water that eventually resulted in the overheating of the cylinder cover. That then caused an automated slow-down of the engine and reduced the ship's maneuverability. These fractures can be caused by the following:

- Stress corrosion cracking
- Inadequate coolant water treatment
- Excessive rust and scale development
- Use of wrong bolts to secure cooling jacket
- Blockages of coolant flow throughout jacket space and cylinder cover passages
- Overheating / thermal expansion of cylinder cover causing excessive stress on jacket cover
