# UNITED STATES COAST GUARD

## MARINE SAFETY LESSONS LEARNED

Lessons Learned 01-19

### **Avoid delays and keep your ship on schedule!** **Does your BilgMon 488 Bilge Alarm / Oil Content Meter operate properly?**

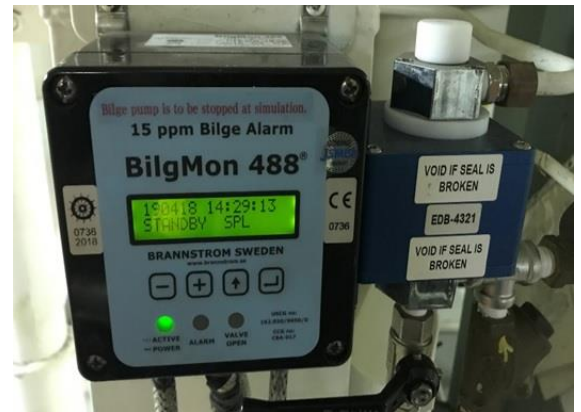
The specific monitor in these cases was the BilgMon 488 model manufactured by Brannstrom, a Swedish company. The older model, BilgMon 488 shown on the right, has a battery that is not replaceable by the crew inserted behind the circuit board of the Bilge Alarm. The purpose of the battery is to maintain the stored data and Real Time Clock (RTC) when the unit is disconnected from a power supply. The circuit board contains two contact points which provide the ability to measure the battery voltage. In all four cases, the battery voltage was extremely low and failed to provide the required 2.5 volts necessary to maintain the stored data without error. As a result, when the data was viewed on the LCD screen it was scrambled and inaccurate. The operator's manual for this model clearly states that, under no circumstances should the battery be removed. Furthermore, a red warning sticker is affixed to the circuit board as pictured above. Attempting to remove the battery in this circumstance may cause an unrecoverable error, failure and data loss. A manufacturer's representative indicated that the battery was originally designed to last the lifetime of the device and that if the RTC stops due to a power supply

failure combined with a low back-up battery voltage, the unit is locked down and the display reads "RTC check: FAILED." [Click here for the applicable manual.](#)<sup>1</sup>

As a result of these discoveries the Coast Guard **strongly recommends** that ship owners and operators whose vessels use the BilgMon 488 to:

- Remind vessel engineers to routinely review the stored data available through the LCD display ensuring that the data matches the information recorded in the ORB and actual OWS operations.
- Maintain awareness that Port State Control Officers performing MARPOL examinations will verify that the BilgMon 488 is recording data properly and is aligned with the ORB entries. **Avoid potential departure delays.**
