# Case Study

# PSC Detentions

**KR Survey Team**

August 2020

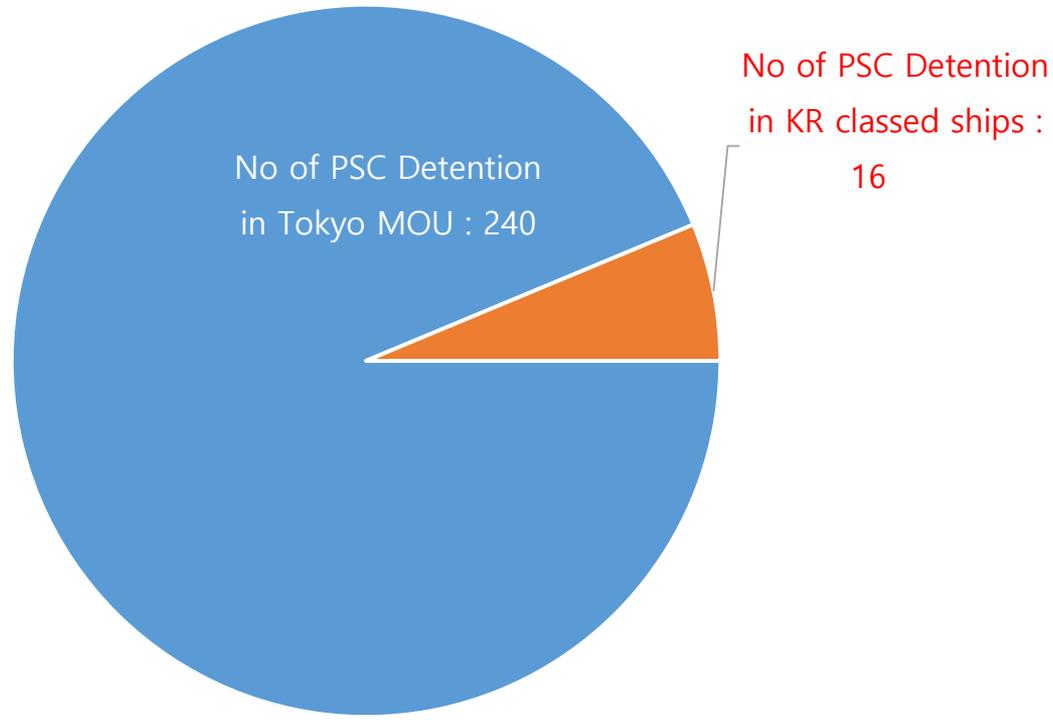
**KR PSC Performance in Tokyo MOU (2020.01 ~ 2020.06)**

**Percentage of ships detained by Tokyo MOU**

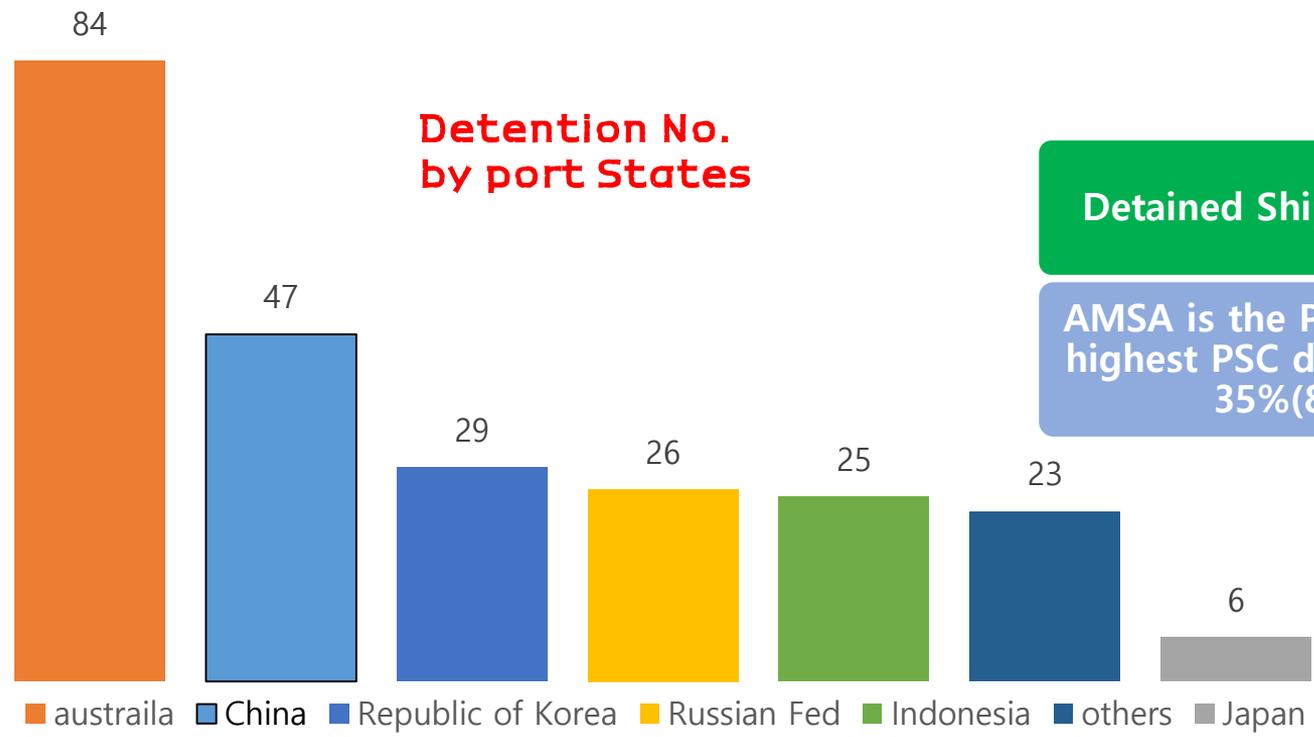
**Detentions : 16 ships registered in KR**

- Category**
- Fire Safety & Life Saving
  - Safety of Navigation
  - Pollution Prevention
  - ISM and others

Detentions by Port Authorities (2020.01 – 2020.06)

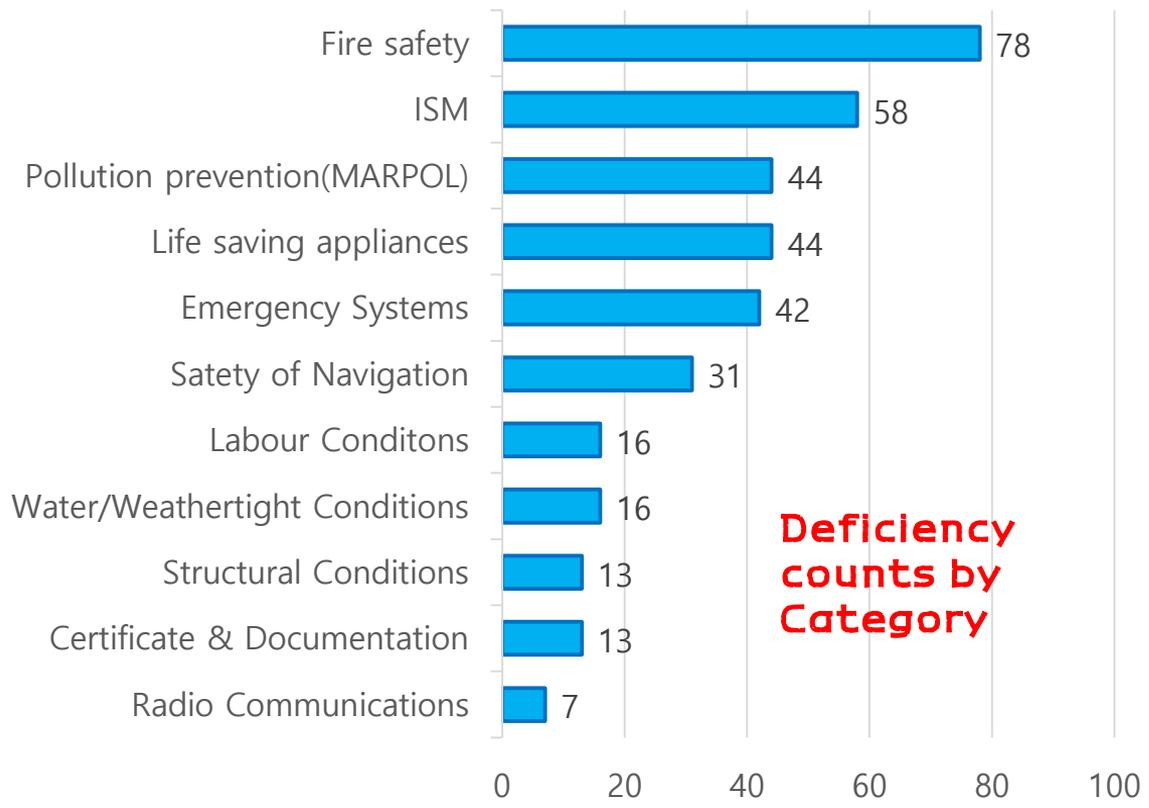
## Detainable Deficiencies by Categories in Tokyo MOU (2020.01 – 2020.06)

**Deficiency counts by Category**

**Detained Ship Nos. : 240 Ships**

**A total of 557 Detainable Deficiencies recorded**

**Top Three Categories of Detainable Deficiencies**

- 1. Fire Safety (14.0%)**
- 2. ISM (10.4%)**
- 3. Life Saving, Pollution (7.8%)**
