Tokyo MOU

Case Study for Detention

KR Survey Team

September 2018

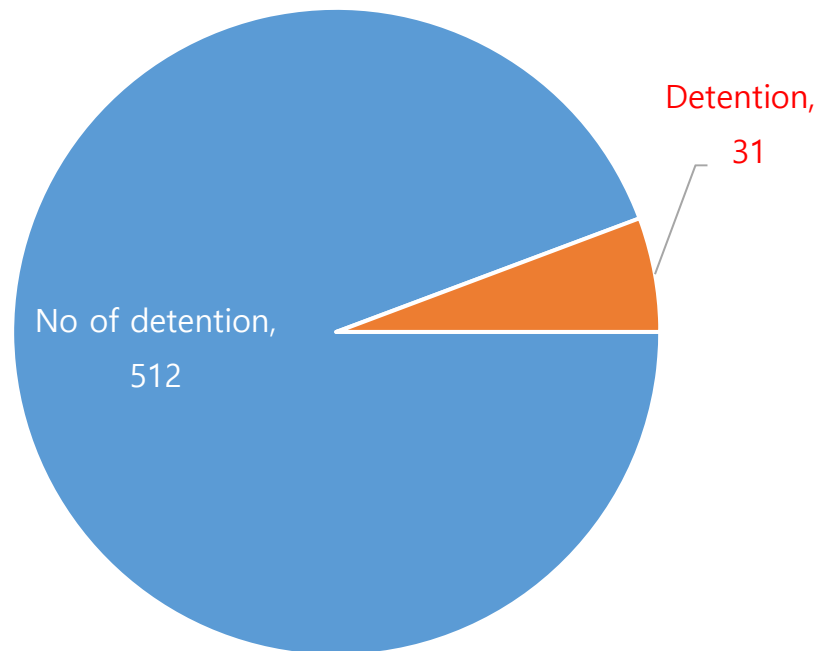
Detention : 31 ships registered in KR

Category

- Fire Safety & Life Saving
- Safety of Navigation
- Pollution Prevention
- ISM and others

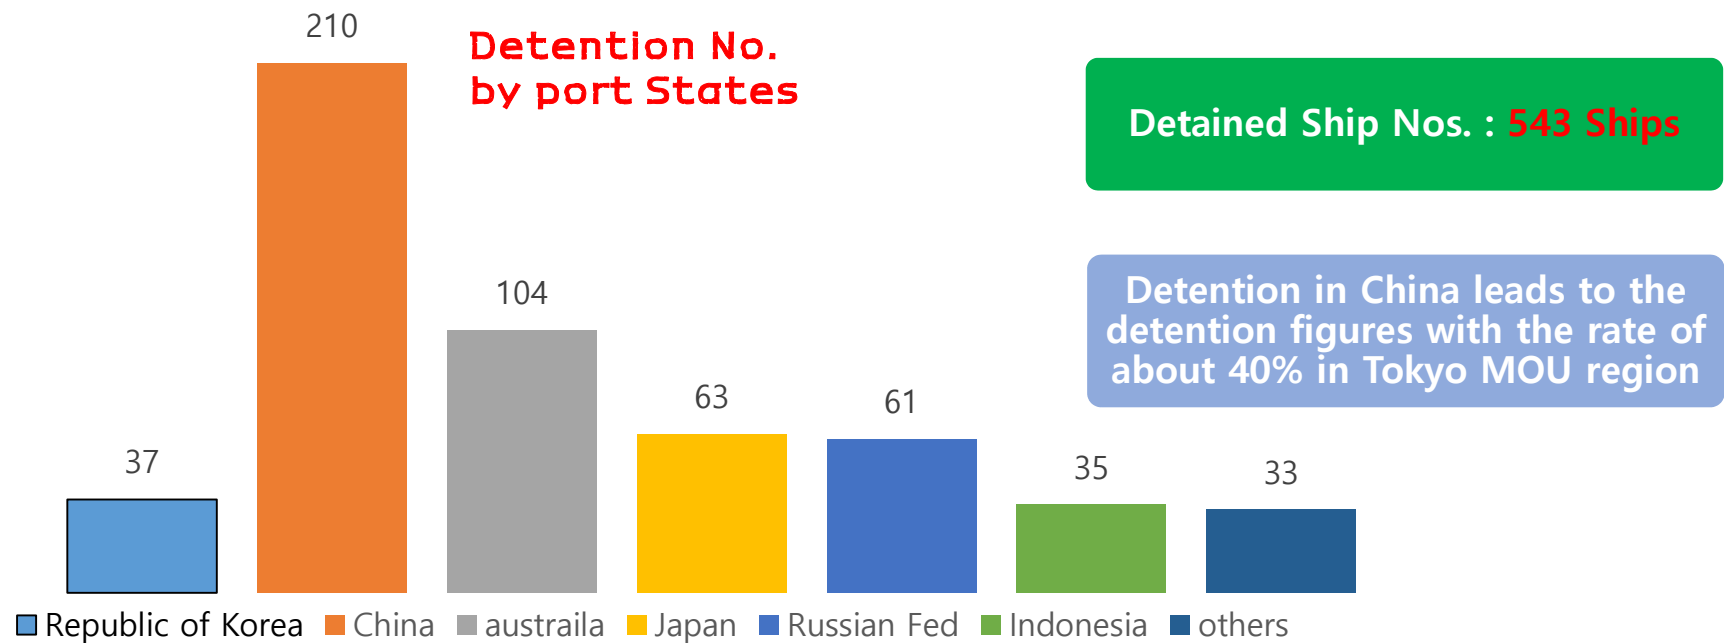
Detention by Tokyo MOU, including ships registered in other Classes (2018.01 ~ 2018.06)

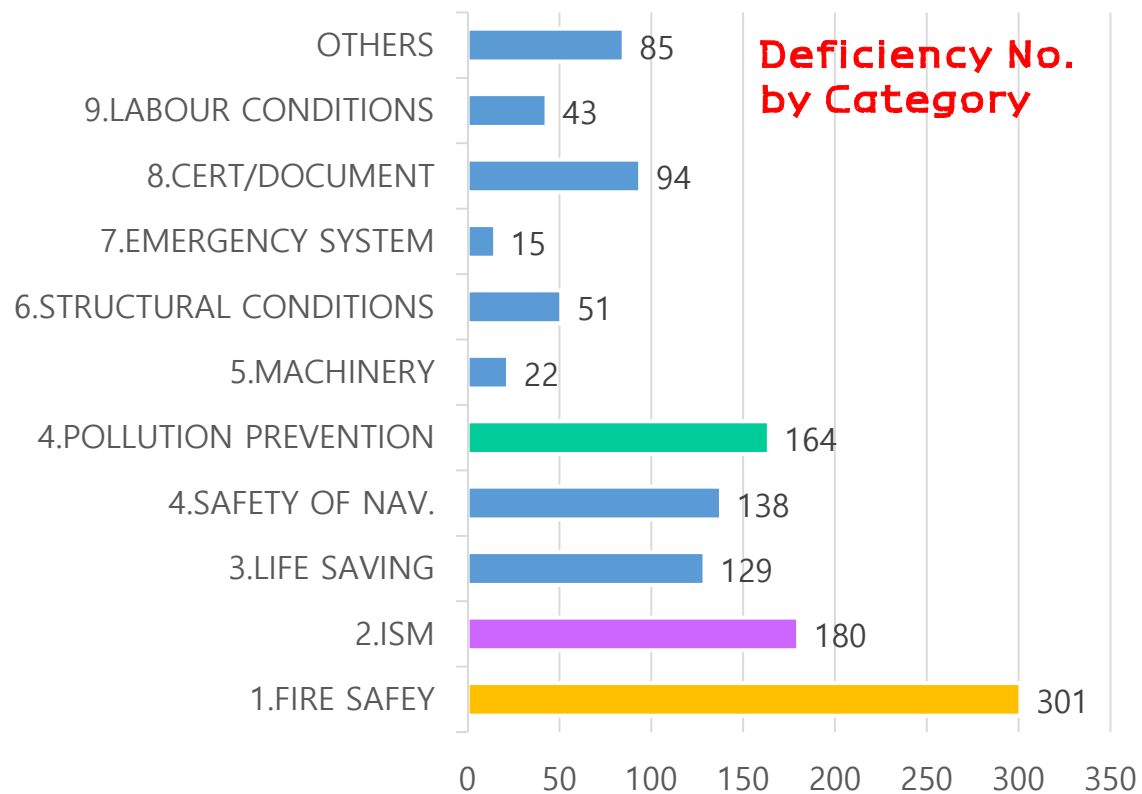
Detention by Tokyo MOU , including ships registered in other Classes (2018.01 ~ 2018.06)

Detained Ship Nos. : **543 Ships**

Deficiency No. of detained ships :
Abt. 1222 deficiencies

1. FIRE SAFETY 2. ISM 3. POLLUTION PREVENTION

The most top three detainable deficiencies in the region with 645 deficiencies (Abt. 52%)
